DEPARTMENT OF TRANSPORTATION**DIVISION OF ENGINEERING SERVICES**

Contract #: 04-0120F4Cty: SF/ALA Rte: 80 PM: 13.2/13.9File #: 82.28**WELDING INSPECTION REPORT****Resident Engineer:**Pursell, Gary**Address:** 333 Burma Road**City:** Oakland, CA 94607**Report No:** WIR-016458**Date Inspected:** 13-Aug-2010**Project Name:** SAS Superstructure**OSM Arrival Time:** 500**Prime Contractor:** American Bridge/Fluor Enterprises, a JV**OSM Departure Time:** 1330**Contractor:** Westmont Industries**Location:** Santa Fe Springs, CA.

Bridge No: 34-0006**Component:** Travelers**Summary of Items Observed:**

Traveler E2/E3-EB

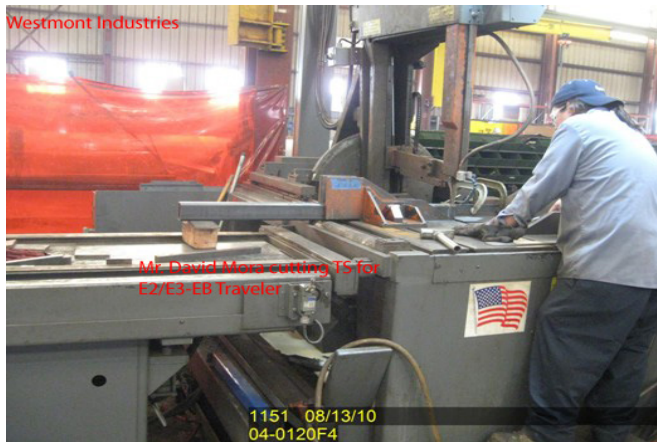
On this date, the QA Inspector observed that WMI production Mr. David Mora was continuing to cut angles on rectangular and square Tube Steel (TS) for the E2/E3-EB Traveler, at production station identified as # 3.

The QA Inspector observed that a Hem Saw brand VT 130A-60 adjustable angle band saw, was being utilized to perform this task.

The QA Inspector observed that Mr. Mora had placed a square wooden 4" x 4" wooden block on one end of the TS to lift, so that the required angle could then be cut with the band saw.

The QA Inspector then observed, that once the angles were cut on the TS material, Mr. Mora then placed the material on a wooden pallet, nearby the work area and later observed that the material had been transferred to a laydown area in the production bay and strategically placed in piles, for future fit-up and tack welding, on the

The QA Inspector observed that the above mentioned material had been previously inspected by the QA Inspector and appeared to be in compliance with the contract requirements.
